Effects of Light Rail Transit Ground Vibrations on the Southern Railway Bridge over Roxboro Street, Durham, NC

Durham-Orange Light Rail Transit Project

July 2015

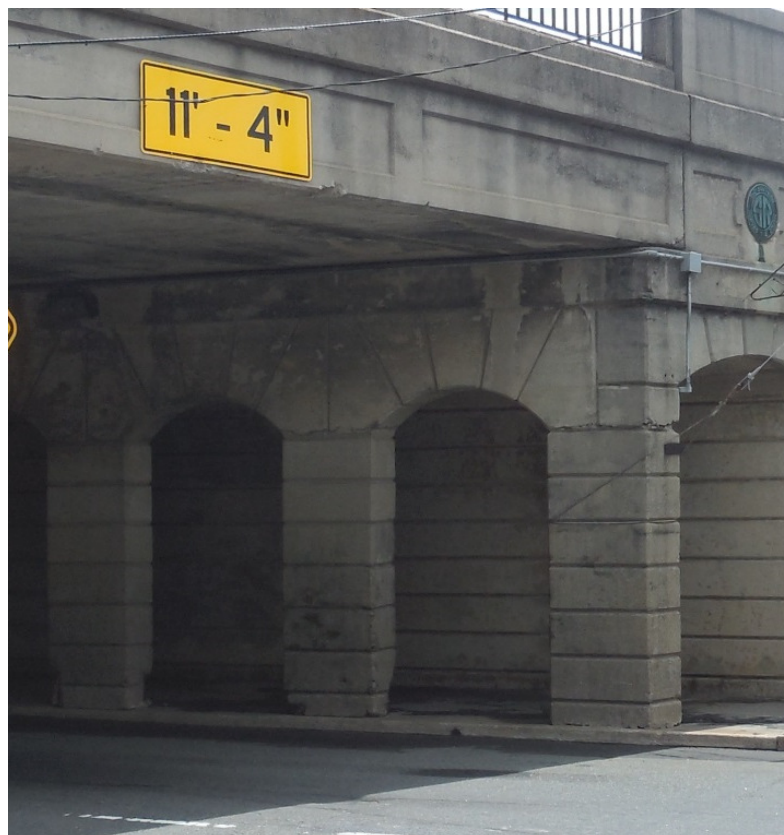
The structural integrity of the bridge itself was not fully investigated during this visit. As can be seen in the image in [Figure 1-1](#), there is significant damage to and spalling of the bottom of the reinforced concrete columns observed to be around 6 inches deep.

Figure 1-1 Spalls at base of columns and vehicle impact damage to fascia beam

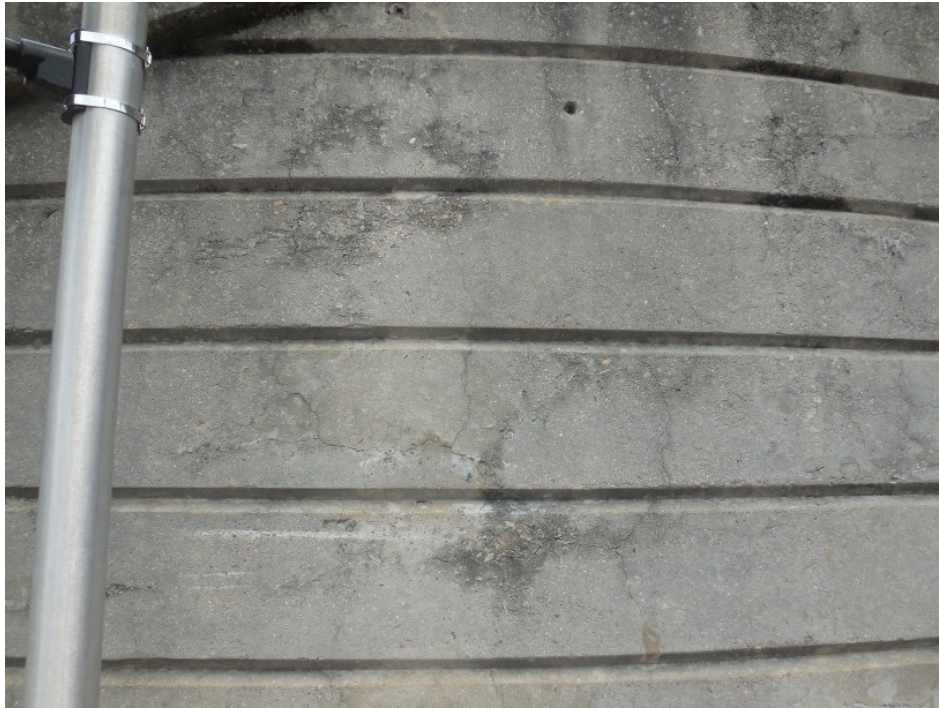
The primarily visual inspection focused on the wing wall on the southwest corner of the bridge adjacent to Pettigrew Street. As indicated in [Figure 1-2](#), there is map cracking up to 1/8 inch in width over the entire surface of the wall although most of the cracking is hairline or 1/16 inch in width. It is not uncommon to find this kind of pattern cracking on the surface of older reinforced concrete walls and is not an indication of a reduction in the structural integrity of the wall. This wing wall is more than 80 years old and appears in satisfactory condition considering its age.

Figure 1-2 Map cracking on southwest wing wall

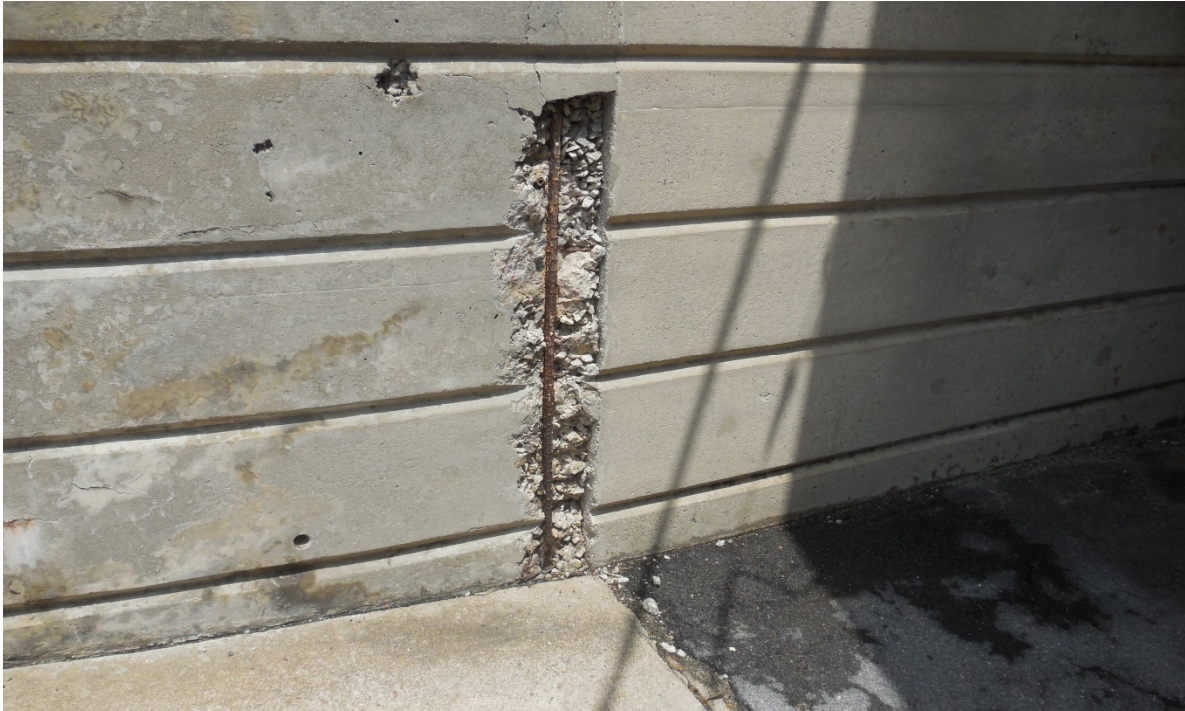
[Figure 1-3](#) shows a spall located at the joint between the abutment and the reinforced concrete wing wall measuring 12 inches wide by 6 feet tall and up to 3 inches deep. Reinforcing steel was exposed and some corrosion was evident. The presence of loose aggregate may indicate poor consolidation of the concrete during construction which caused the local defect that ultimately led to this face concrete spall. No other significant damage was observed along the exposed area of the wing wall.

Figure 1-3 Spall at abutment joint with southwest wing wall

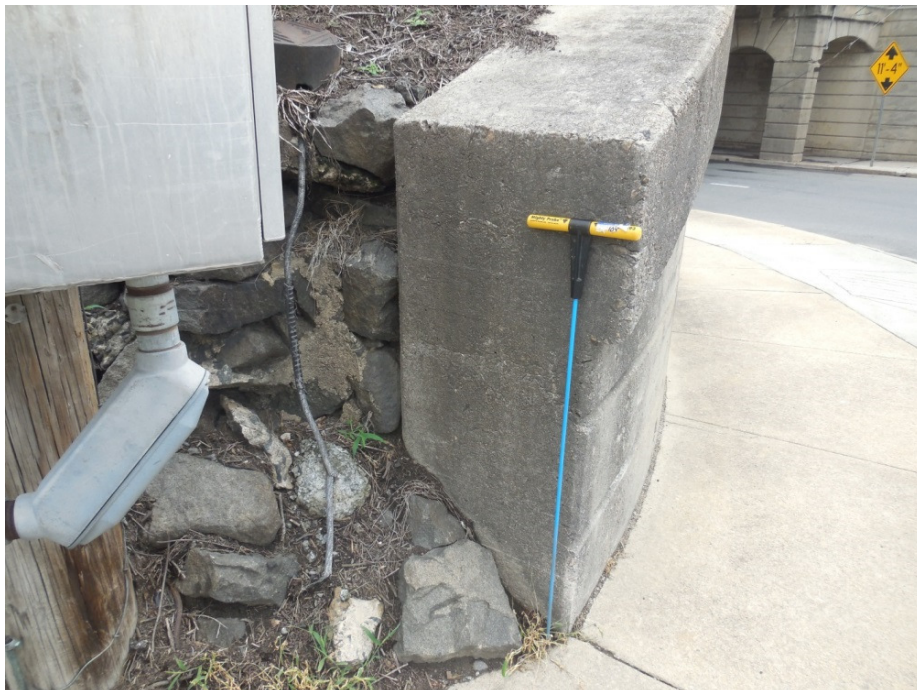
The Southern Railway Bridge design drawings are attached as Appendix B and indicate the wing wall rests on a spread footing extending at least 12 inches beyond the wall at the base. To estimate the depth of the spread footing supporting the wing wall, a small area of soil along the corner of the wall was located which was suitable to probe. A clear obstruction was found at a depth of 35 inches below the soil that appeared to be the top of the concrete footing. Without excavation or test holes, the top of footing depth cannot be assured.

Figure 1-4 Probe used to estimate spread footing depth

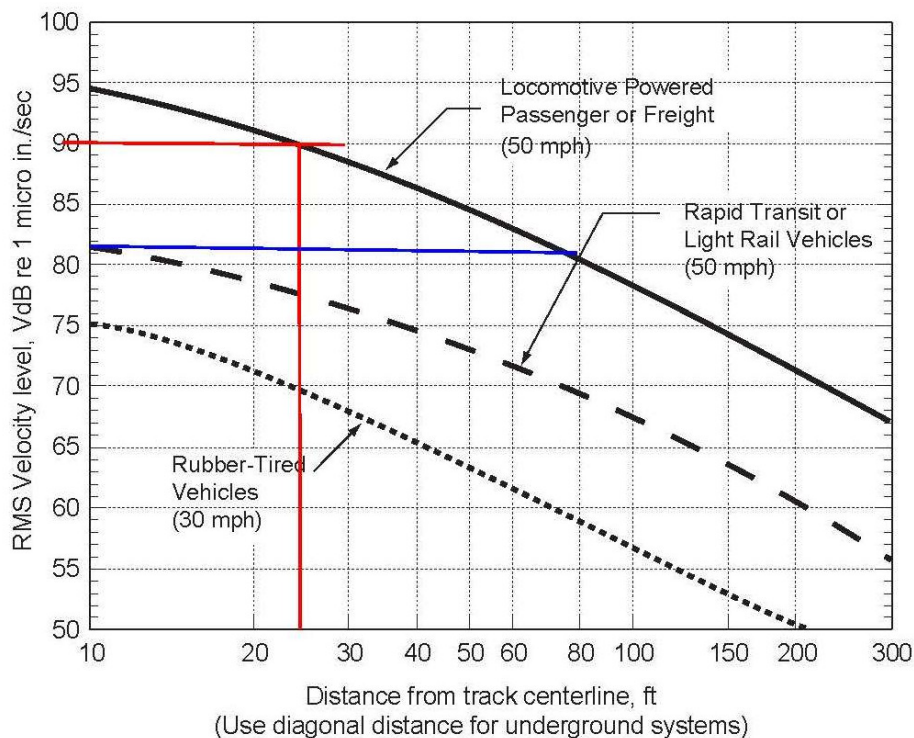
Figure 2-1 Reference Figure 10-1 from the FTA Transit Noise and Vibration Assessment Guidelines

Plotting the relative distances of each rail line on Figure 10-1 of the FTA *Transit Noise and Vibration Assessment Guidelines*, one can observe that the freight train vibration intensity is approximately 90 VdB at the wing wall (red line) whereas the LRT vibration intensity (blue line) is approximately 80 VdB. Thus the lower magnitude vibrations of the LRT on the wing wall are equivalent to a freight train at a distance of 80 feet from the wing wall. The LRT passing in close proximity to the wing wall therefore has less impact than the freight rail trains which have been operating on the Roxboro Street Bridge for over 80 years.

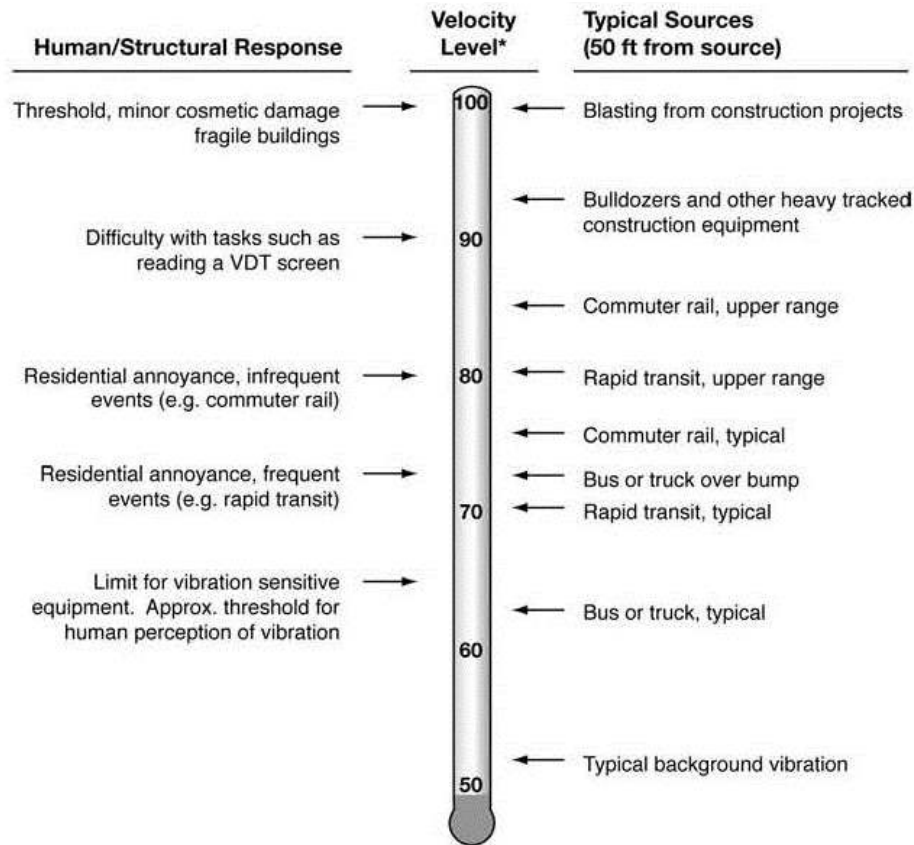
Figure 2-2 Reference Figure 7-3 from the FTA Transit Noise and Vibration Assessment Guidelines

To put the level of ground borne vibration intensity in perspective, Figure 2-2, which is an excerpt from the FTA guidelines (Figure 7-3), shows the impacts that typical levels of ground borne vibration have on the nearby area. As noted in this figure, the velocity level of ground borne vibrations impacting a structure must be 100 VdB to reach the threshold to cause even minor cosmetic damage. Neither the LRT nor the freight rail vibrations approach this level. Therefore, based on the typical conditions encountered within a transit project, there should be no negative impact to the Roxboro Street rail road underpass due to ground borne vibrations. It is, however, recommended that a thorough geotechnical investigation be performed during final design to ensure that no geological special conditions or properties exist that could intensify ground borne vibrations beyond what has been presented herein.

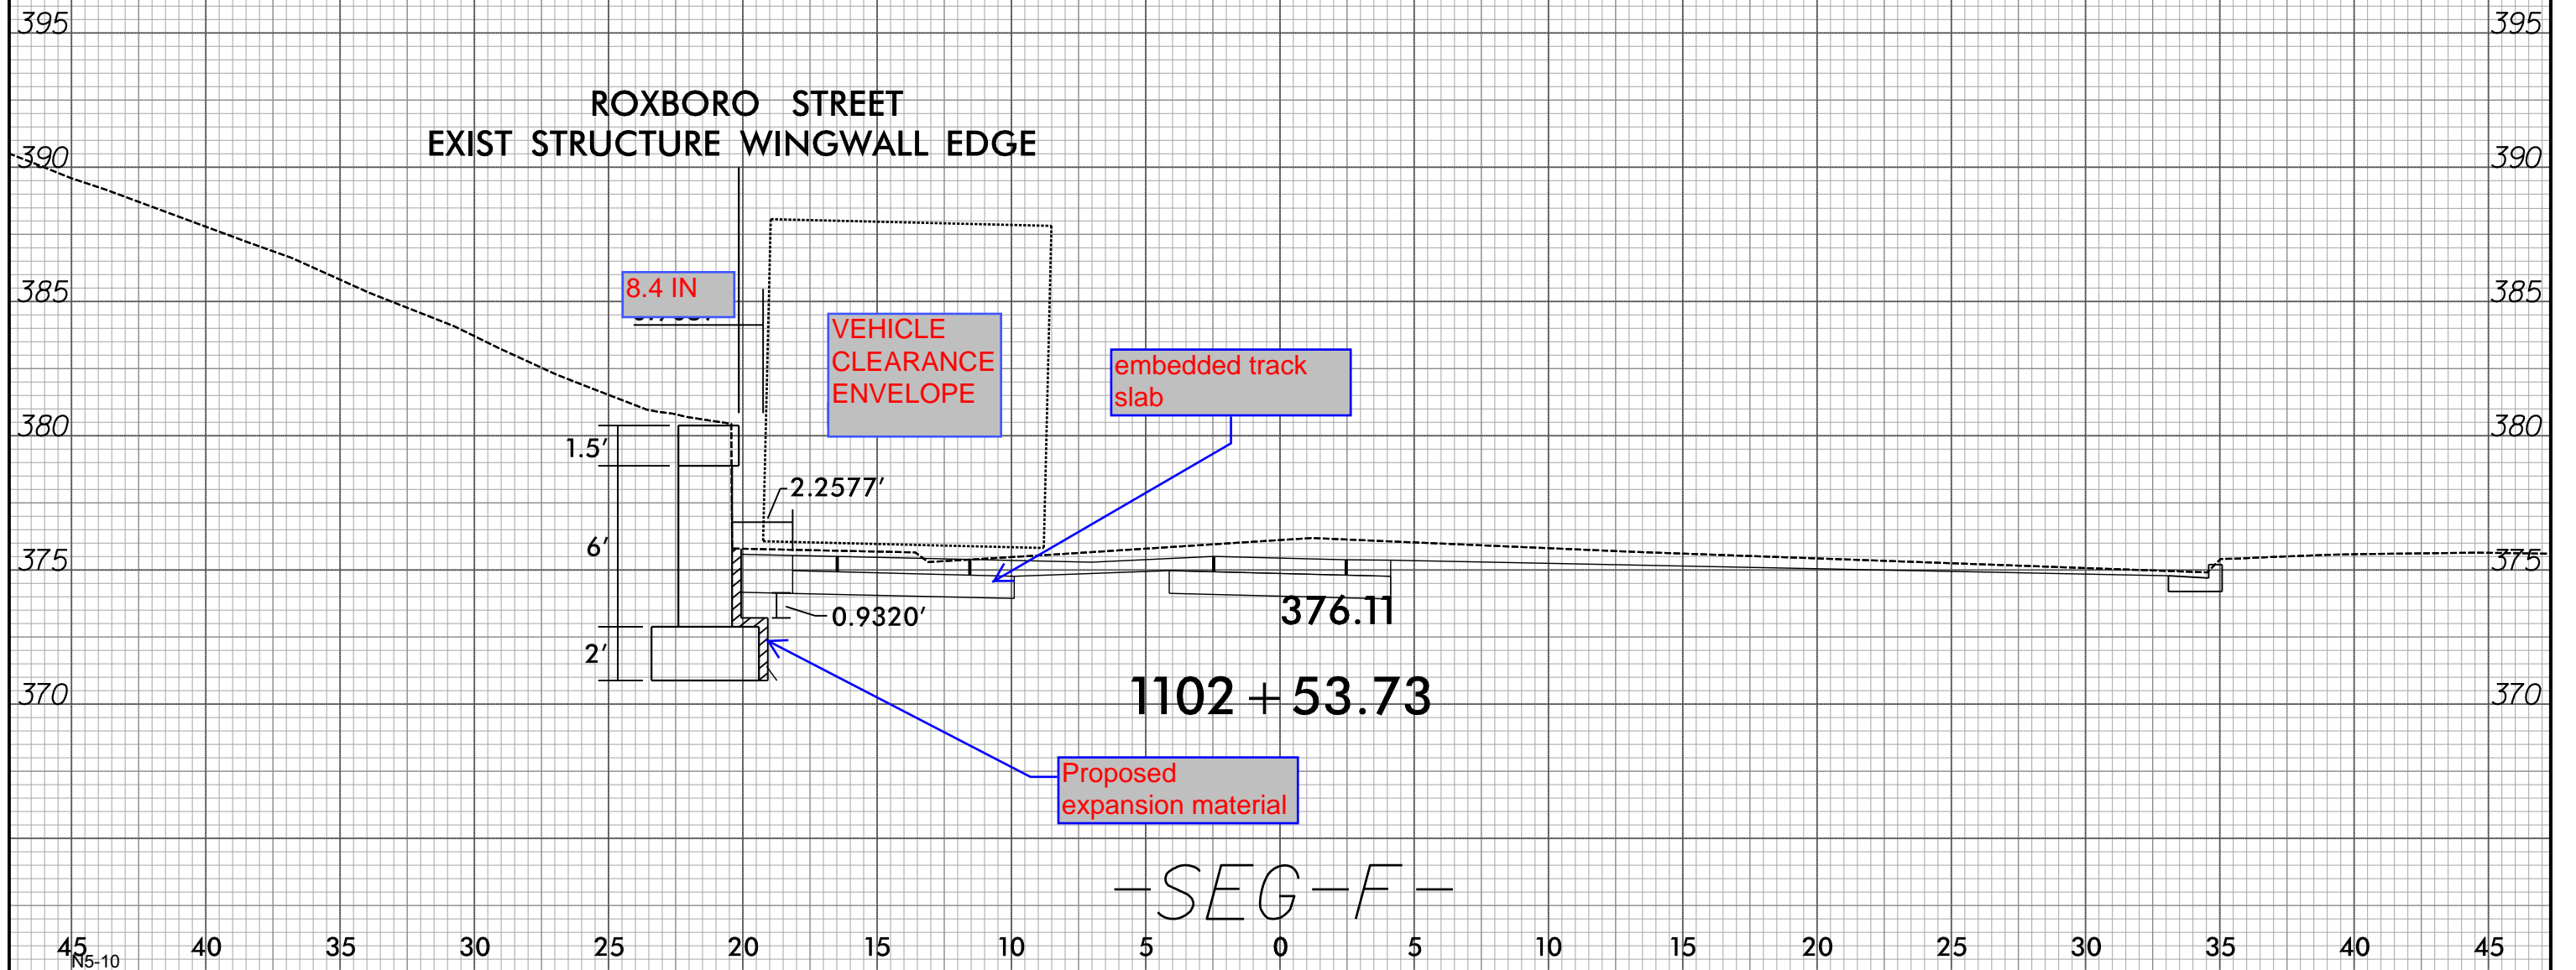
APPENDIX A- CROSS-SECTION OF PROPOSED LRT AT EXISTING WING WALL
Effects of Light Rail Transit Ground Vibration on the Southern Railway Bridge over Roxboro Street

Distances based upon field measurements to existing wall. Concrete surface at wall would be within +/- 0.1' from existing with expansion material placed between surfaces.
