Appendix I: Proposed Refinements Hazardous Materials Technical Report

Durham-Orange Light Rail Transit Project

Attachment I.3: Site Photographs

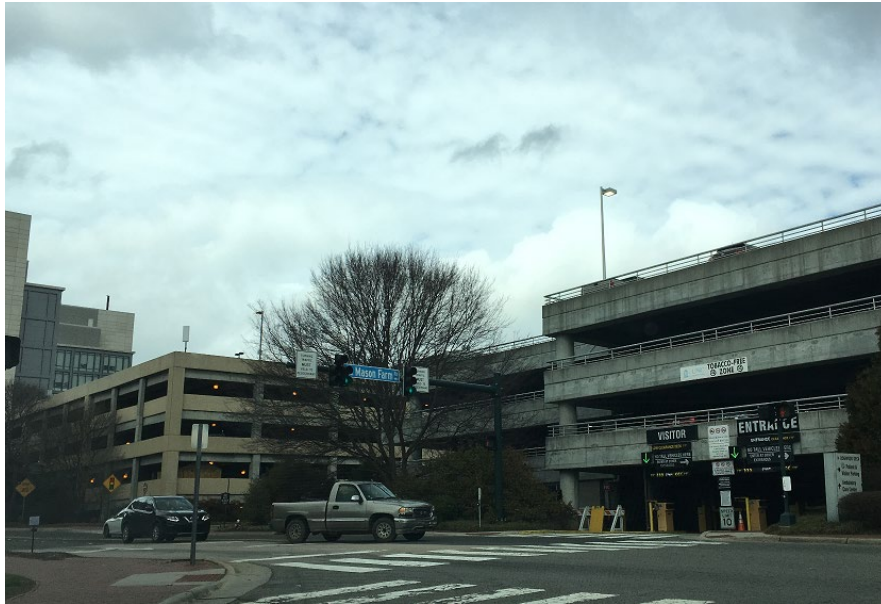
Photo 1: Current corridor start, near UNC Chapel Hill Campus and Victory Village Daycare (reported as a previous LUST case). View is to the northwest.

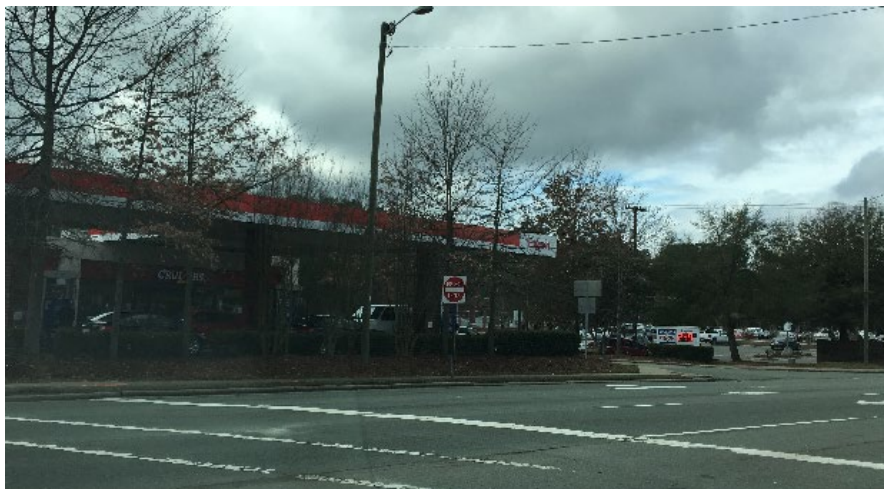
Photo 2: Current Exxon Station (previously identified as a LUST Medium and elevated to high, with increased proximity to the corridor). View is to the west.

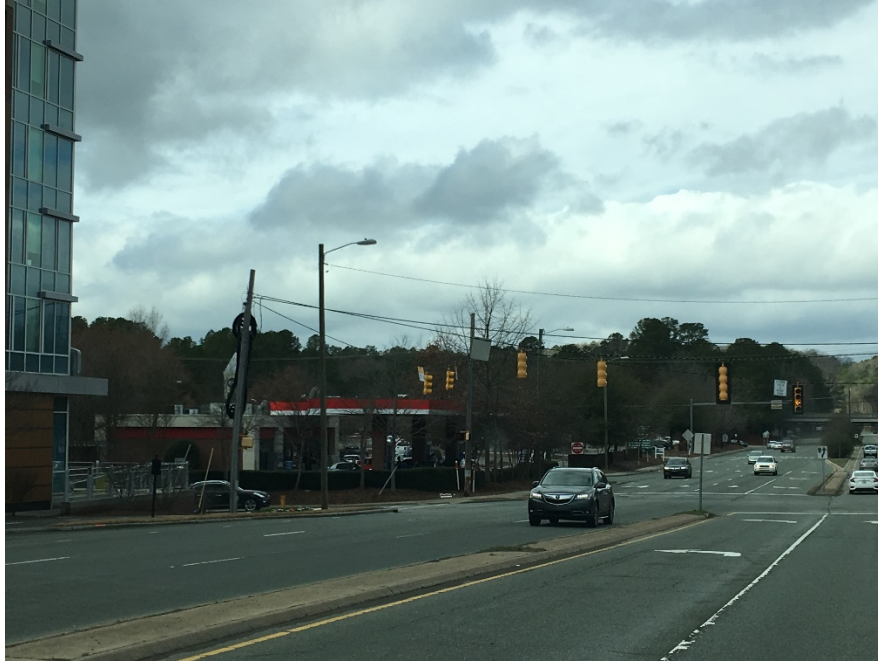
Photo 3: Previous location of East 54 Development (two former USTs were removed and 200 tons of impacted soil was excavated). View is to the west.

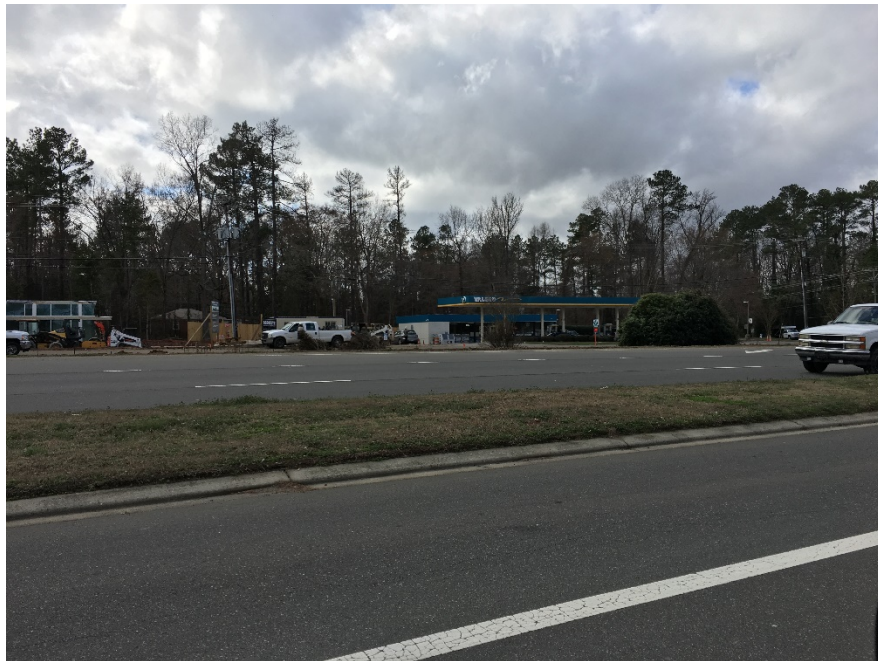
Photo 4: Existing Valero Gas Station (previously omitted site). View is to the south from Raleigh Road.

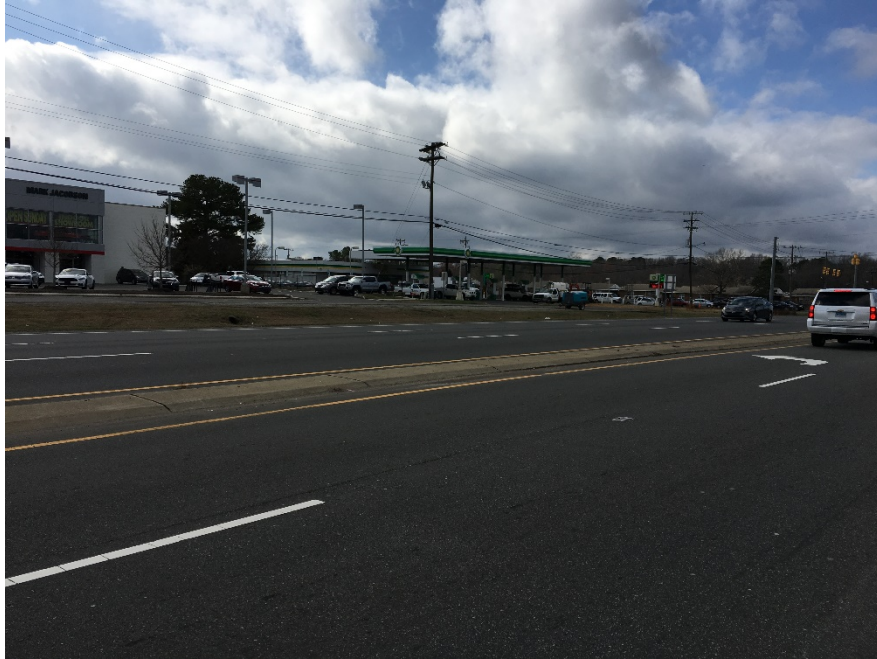
Photo 5: Existing Garrett Road BP Station (high risk site with LUST, Historic Auto and 5 USTs). View is to the southwest from Durham Chapel Hill Boulevard

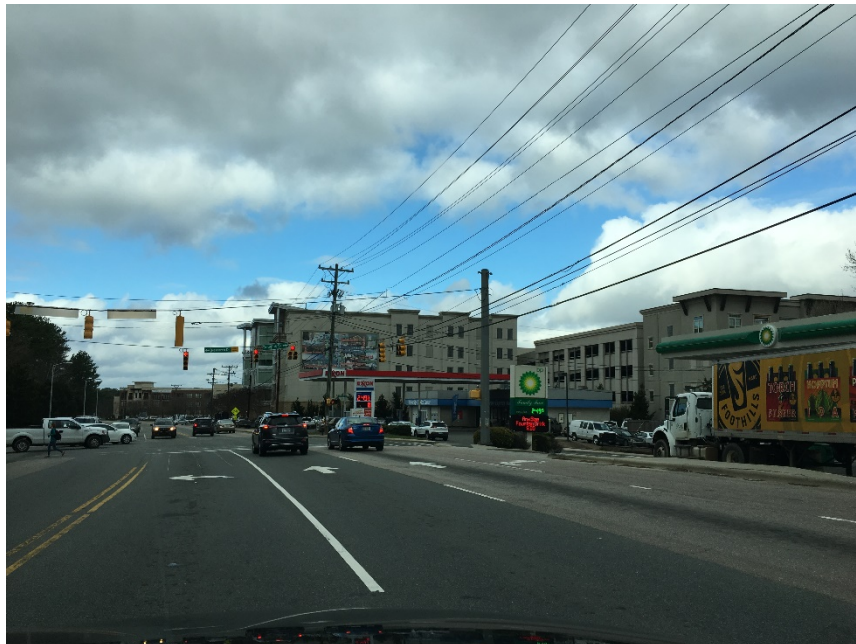
Photo 6: Multiple sites (BP station, Exxon station, and Durham Dry Cleaning site) along Erwin Road. View is to the west.

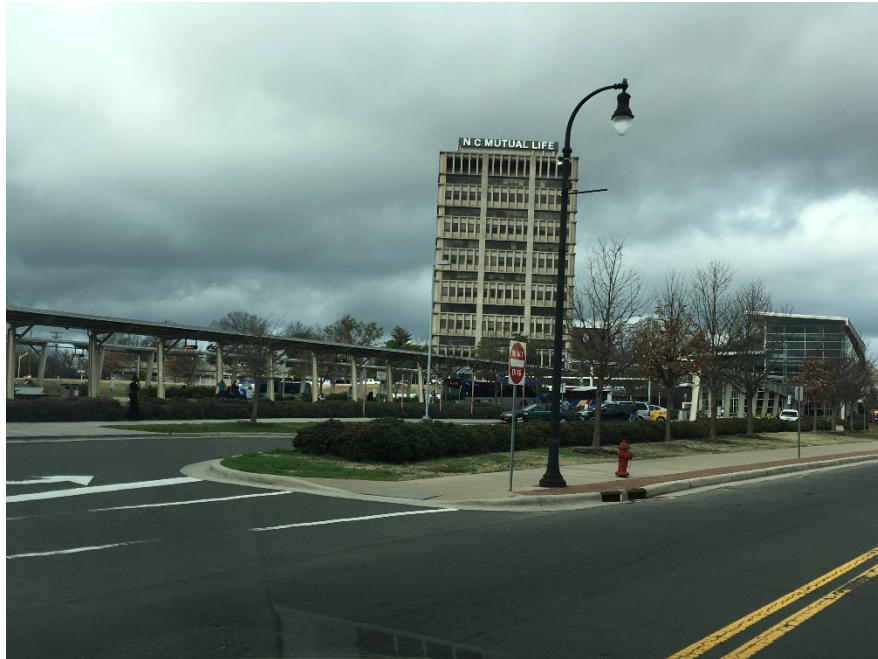
Photo 7: Future LRT Project Durham Station (expansion of existing bus station). View is to the northwest along West Pettigrew Road.

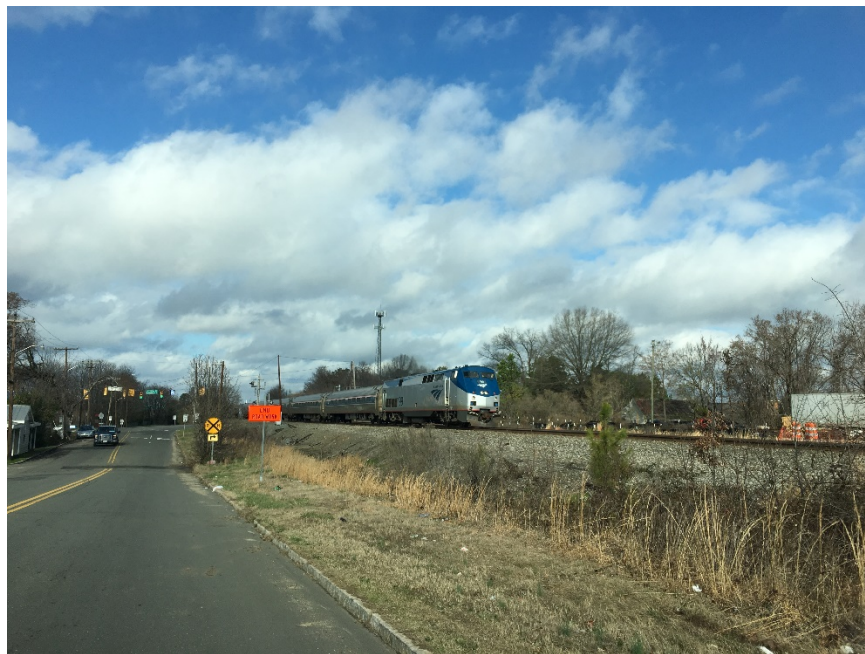
Photo 8: Northeast portion of the corridor near new NCCU extension. View is to the south along the existing railway and East Pettigrew Street.

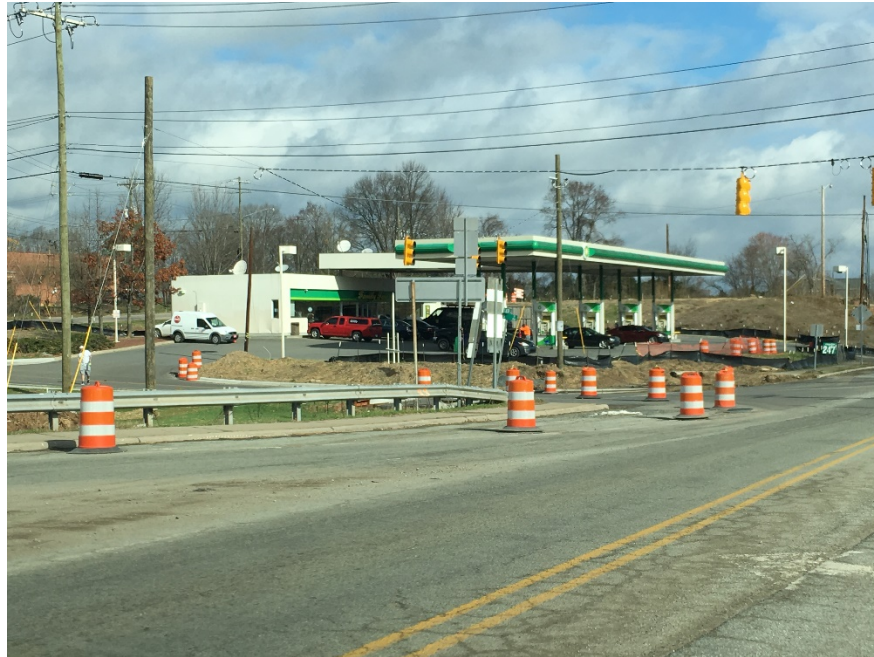
Photo 9: Existing freeway BP Station located near intersection of Pettigrew Street and Alston Avenue (ongoing UST, LUST, LUST TRUST regulatory listings). View is to the north.

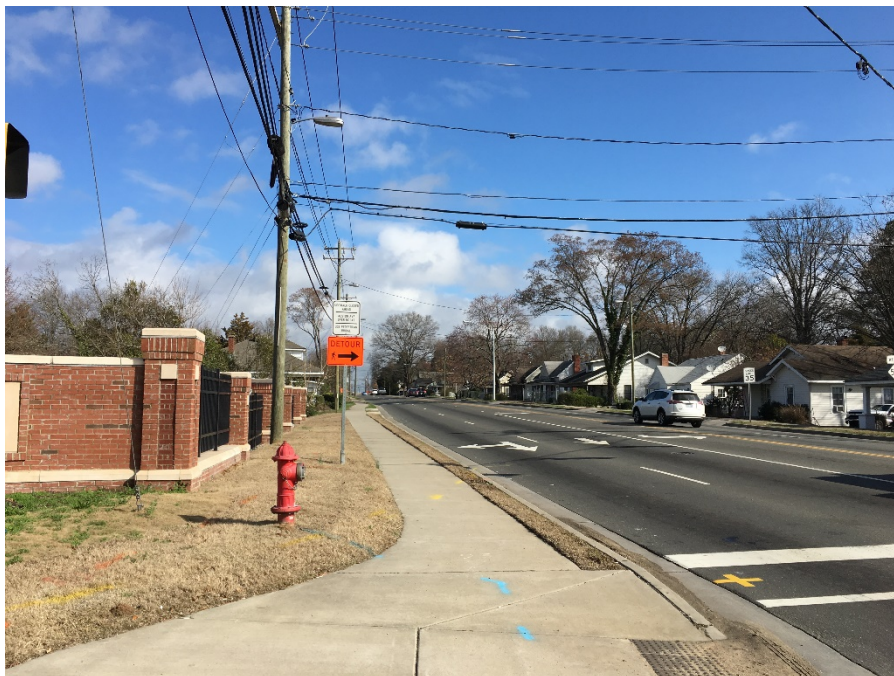
Photo 10: Future location of NCCU Station (near NCCU residence LUST). View is to the north.
