GoTriangle RFQ 24-048

GoTriangle Bus Operations and Maintenance Facility Space and Efficiency Assessment

Draft Report

August 27, 2019

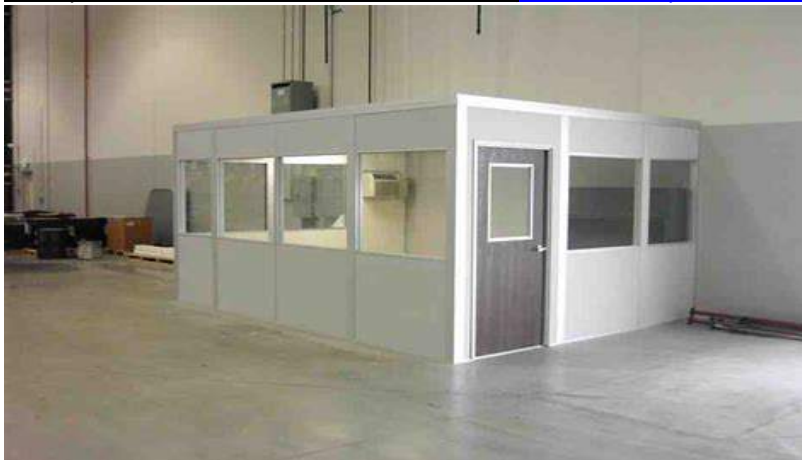
Example of modular offices for mezzanine (www.unitedpartition.com):

The need for 6 additional maintenance supervisor offices can be addressed through incorporation of modular-type offices. It is proposed to place two modular offices on the mezzanine area overlooking the maintenance bays. Additionally, it is proposed to incorporate a “tower-type” modular office mezzanine along the back wall of the maintenance shop in the location of the current tire storage and brake shop area (across the circulation aisle from lift bays #5 & 6). It is proposed to use the ground level underneath the tower-type offices for a training space for maintenance staff. The graphics below show examples of modular offices for these 2 locations - see the end of this section for a floor plan location of these areas.

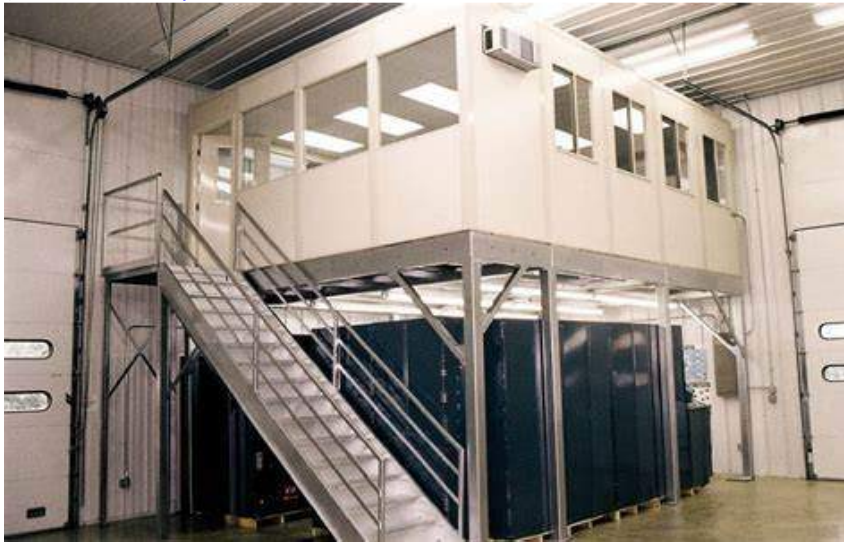
Example of tower-type modular offices for back wall of maintenance shop
(www.nationalpartitions.com):

It is assumed in the cost estimate and schedule development that the modular will sit on top of the existing slab and structural modifications, cutting into the slab or relocation of underground utilities are not needed.

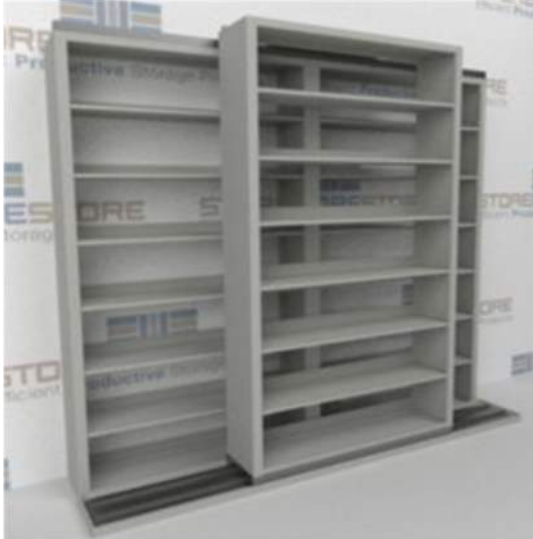
Example of a sliding shelving application (www.southwestsolutions.com):

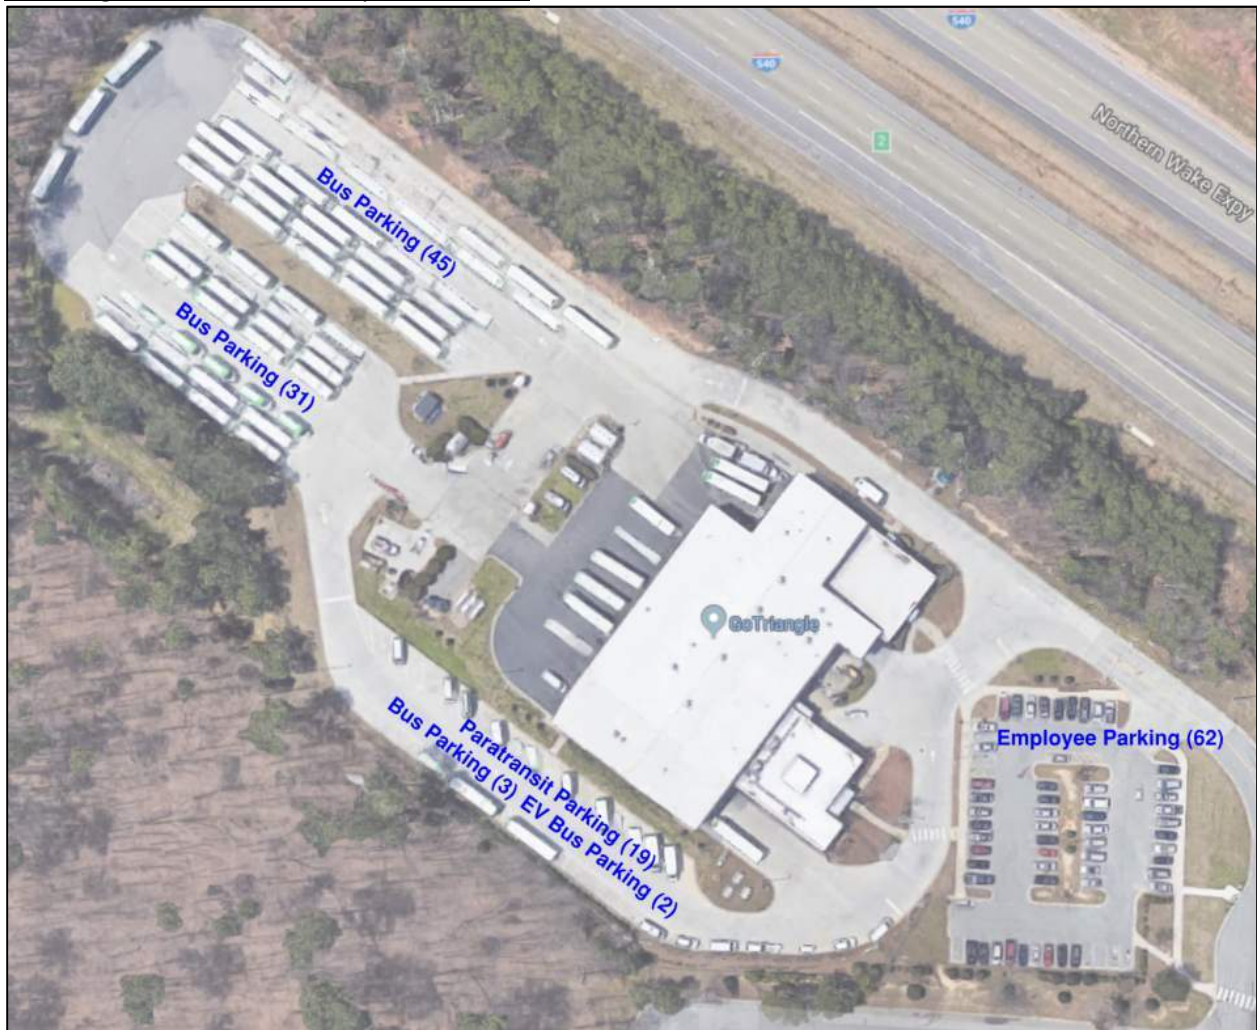
GoTriangle BOMF Site with Capacities Listed

Vehicle Type	Current Need	Maximum Capacity	Growth Available
Fixed Route Bus	73	81 with Paratransit on-site	8 (11%)
		91 with Paratransit off-site	18 (25%)
Paratransit Bus	25	19 (Current) 28 or more (New Upper Lot)	Deficient currently 3 (12%)
Car/Service Vehicle	175	139 (Current)	Deficient currently
		216 (with upper lot expansion)	41 (23%)
		200 (w/ Paratransit bldg. on upper lot)	25 (14%)

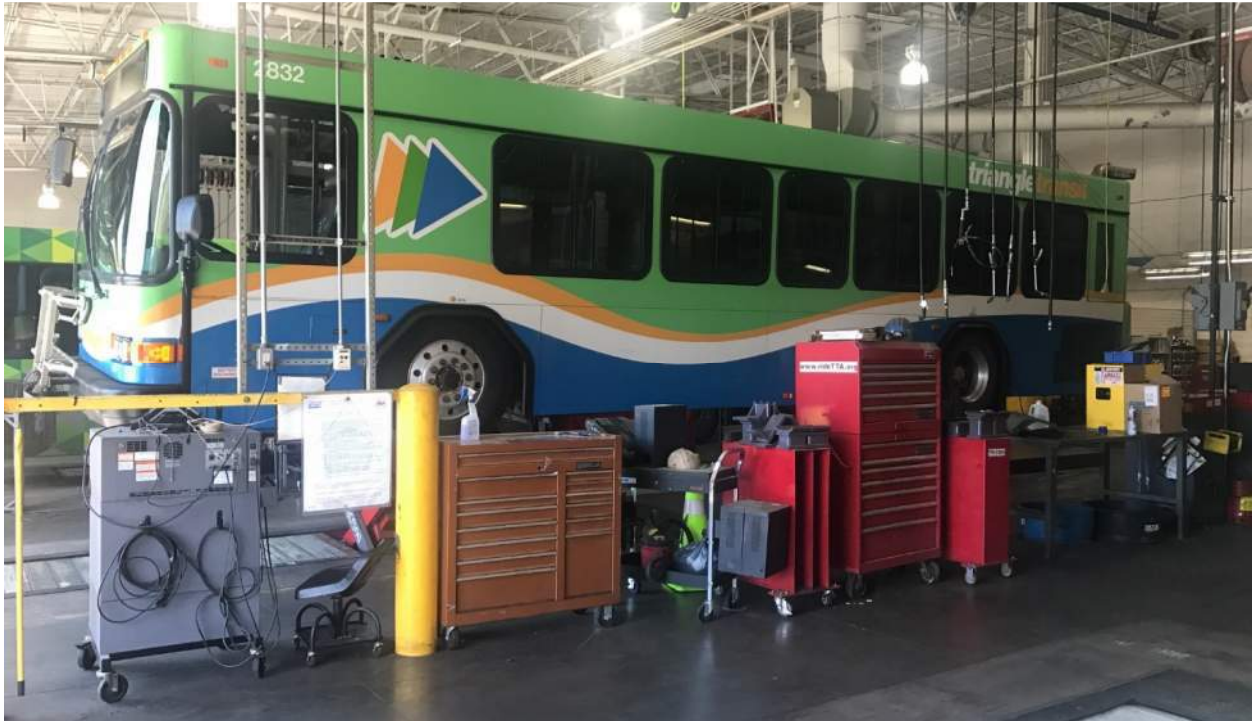
Tools Storage Between Maintenance Bays

- Limited shop space for tool boxes and portable equipment, causing storage to take place between bays
- Work benches and workstations located between bays, restrict circulation around busses during service
- Electronics repair shop has limited space and needs a dedicated bay
- Only 2 bays (9/10) are long enough to pull engine and transmission

The deficiencies identified above can only be resolved by construction of a new facility. However, two operational changes can be made which will improve the operational efficiency of the BOMF:

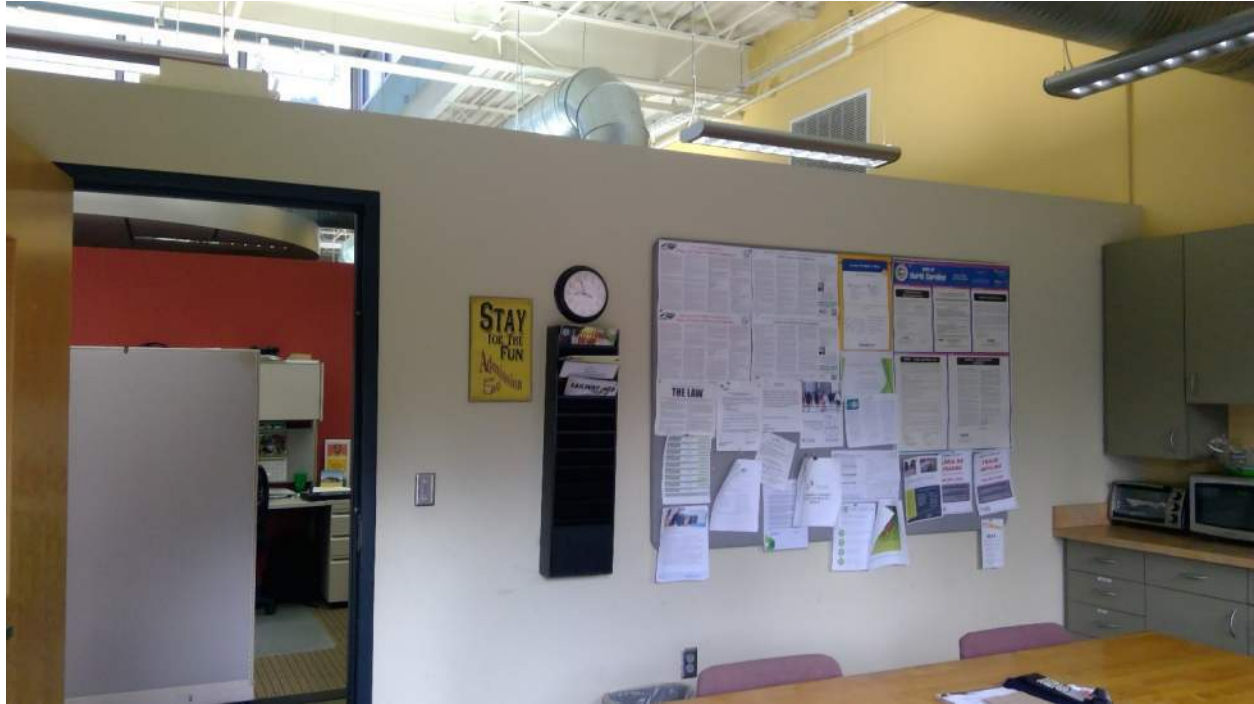
Admin Break Room

- The acoustics in the space cause distractions. As an example, the break room does not have a ceiling and the sound carries throughout the work spaces

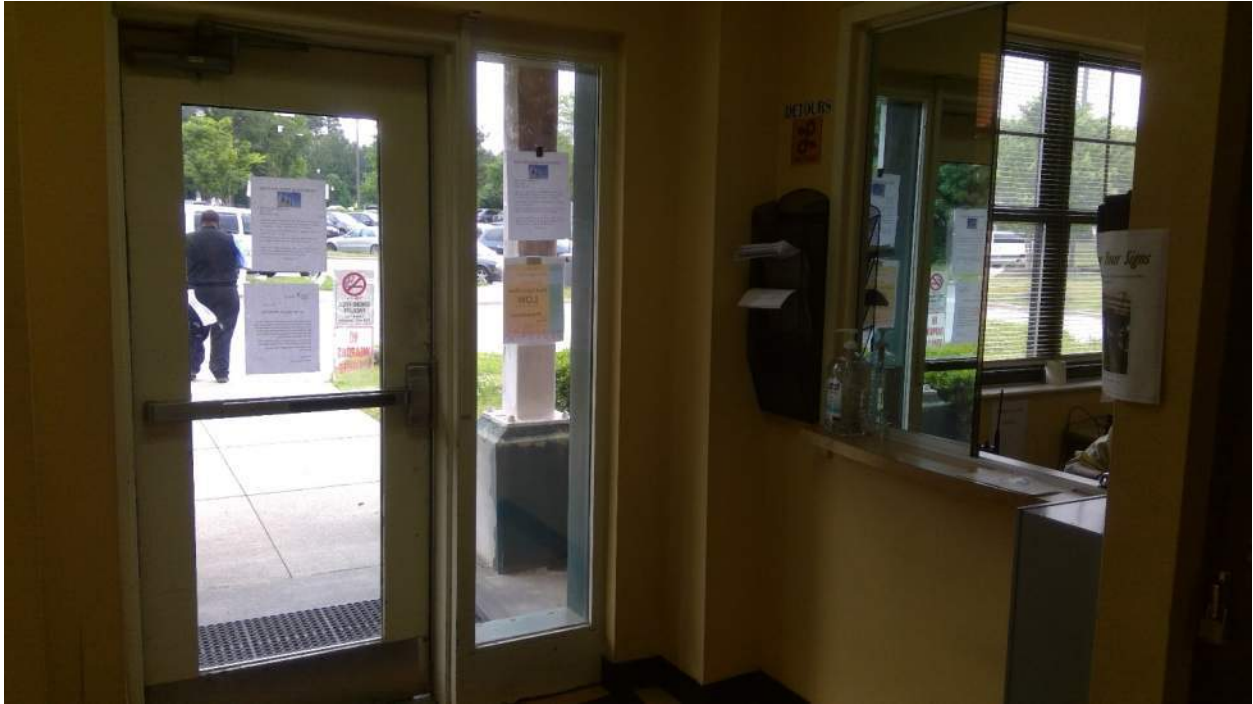
Operations Check In/Dispatch

- Paratransit reservations and dispatch staff sit close together, and clients have difficulty hearing with the background noise
- The bus check in window does not have full height visibility of staff or guests entering space. The area for bus check in and dispatch is not adequate for the number of staff members needing to use the space
- Supervisors do not have offices or available huddle room space for private conversations with staff
- Number of fixtures in restroom are inadequate and there are no showers
- Number of lockers are inadequate for number of drivers
- The layout of the space leads to inappropriate space adjacencies, such as the Paratransit check in window being directly across from the restrooms
